| <b>Survey Reference</b> | B-50239 |

## REFURBISHMENT ASBESTOS SURVEY REPORT

New Lift Area Only  
Regal Theatre  
The Avenue  
Minehead  
TA24 5UQ

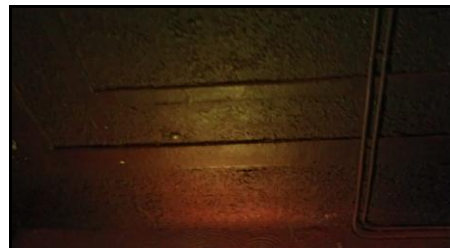
| Ref | Sample No | Floor | Location | Description | Access. | (A)<br>Product Type | (B)<br>Condition | (C)<br>Surface Treatment | (D)<br>Asbestos Type | Material Assessment Score (A + B + C + D) | Priority | Photo |
|---|---|---|---|---|---|---|---|---|---|---|---|---|
| 1 | B-50239/001 | Second Floor | 201 New lift Area - Ceiling | Textured Coating | Low | 1 | 0 | 1 | 1 | 3 | Low | |

| Ref | Sample No | Floor | Location | Description | Access. | (A)<br>Product Type | (B)<br>Condition | (C)<br>Surface Treatment | (D)<br>Asbestos Type | Material Assessment Score (A + B + C + D) | Priority | Photo |
|---|---|---|---|---|---|---|---|---|---|---|---|---|
| 5m² | | AD | Remove If Affected Bu Proposed Refurbishment Works | Work with this material to be carried out in accordance with The Control of Asbestos Regulations (2012.). All waste to be disposed of in accordance with the Hazardous Waste Regulations 2005. | | | | | | | | |

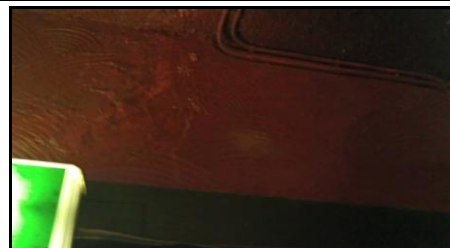
| Ref | Sample No | Floor | Location | Description | Access. | (A)<br>Product Type | (B)<br>Condition | (C)<br>Surface Treatment | (D)<br>Asbestos Type | Material Assessment Score (A + B + C + D) | Priority | Photo | |
|---|---|---|---|---|---|---|---|---|---|---|---|---|--|
| 2 | B-50239/002 | Second Floor | 201 New lift Area – Wall Adjacent Door | Textured Coating | High | 1 | 1 | 0 | 1 | 3 | Low | | |

| Ref | Sample No | Floor | Location | Description | Access. | (A)<br>Product Type | (B)<br>Condition | (C)<br>Surface Treatment | (D)<br>Asbestos Type | Material Assessment Score (A + B + C + D) | Priority | Photo | |
|---|---|---|---|---|---|---|---|---|---|---|---|---|--|
| 5m² | | AD | Remove If Affected Bu Proposed Refurbishment Works | Work with this material to be carried out in accordance with The Control of Asbestos Regulations (2012.). All waste to be disposed of in accordance with the Hazardous Waste Regulations 2005. | | | | | | | | | |

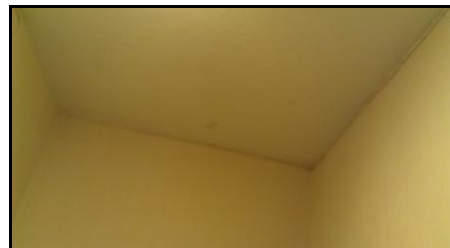
| Ref | Sample No | Floor | Location | Description | Access. | (A)<br>Product Type | (B)<br>Condition | (C)<br>Surface Treatment | (D)<br>Asbestos Type | Material Assessment Score (A + B + C + D) | Priority | Photo |
|---|---|---|---|---|---|---|---|---|---|---|---|---|
| 8 | B-50239/008 | First Floor | 101 New lift Area - Ceiling | Textured Coating | Low | 1 | 0 | 0 | 1 | 2 | Low | |

| Ref | Sample No | Floor | Location | Description | Access. | (A)<br>Product Type | (B)<br>Condition | (C)<br>Surface Treatment | (D)<br>Asbestos Type | Material Assessment Score (A + B + C + D) | Priority | Photo |
|---|---|---|---|---|---|---|---|---|---|---|---|---|
| 6m² | | AD | Remove If Affected Bu Proposed Refurbishment Works | Work with this material to be carried out in accordance with The Control of Asbestos Regulations (2012.). All waste to be disposed of in accordance with the Hazardous Waste Regulations 2005. | | | | | | | | |

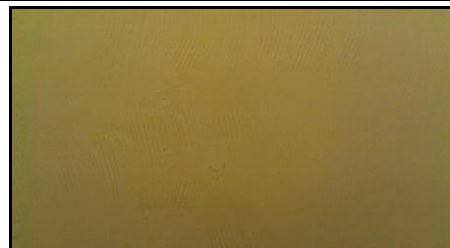
| Ref | Sample No | Floor | Location | Description | Access. | (A) Product Type | (B) Condition | (C) Surface Treatment | (D) Asbestos Type | Material Assessment Score (A + B + C + D) | Priority | Photo | |
|---|---|---|---|---|---|---|---|---|---|---|---|---|--|
| 9 | B-50239/009 | First Floor | 101 New lift Area - Wall | Textured Coating | High | 1 | 0 | 0 | 1 | 2 | Low | | |

| Ref | Sample No | Floor | Location | Description | Access. | (A) Product Type | (B) Condition | (C) Surface Treatment | (D) Asbestos Type | Material Assessment Score (A + B + C + D) | Priority | Photo | |
|---|---|---|---|---|---|---|---|---|---|---|---|---|--|
| 8m² | | AD | Remove If Affected Bu Proposed Refurbishment Works | Work with this material to be carried out in accordance with The Control of Asbestos Regulations (2012.). All waste to be disposed of in accordance with the Hazardous Waste Regulations 2005. | | | | | | | | | |

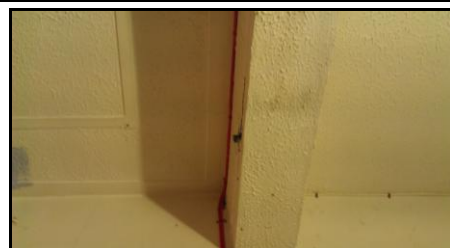
| Ref | Sample No | Floor | Location | Description | Access. | (A) Product Type | (B) Condition | (C) Surface Treatment | (D) Asbestos Type | Material Assessment Score (A + B + C + D) | Priority | Photo | |
|---|---|---|---|---|---|---|---|---|---|---|---|---|--|
| 11 | B-50239/011 | Ground Floor | 001 New lift Area – Ceiling, Beams & Timber Strips | Textured Coating | Low | 1 | 0 | 0 | 1 | 2 | Low | | |

| Ref | Sample No | Floor | Location | Description | Access. | (A) Product Type | (B) Condition | (C) Surface Treatment | (D) Asbestos Type | Material Assessment Score (A + B + C + D) | Priority | Photo | |
|---|---|---|---|---|---|---|---|---|---|---|---|---|--|
| 8m² | | AD | Remove If Affected Bu Proposed Refurbishment Works | Work with this material to be carried out in accordance with The Control of Asbestos Regulations (2012.). All waste to be disposed of in accordance with the Hazardous Waste Regulations 2005. | | | | | | | | | |

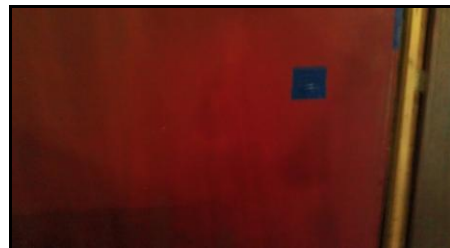
| Ref | Sample No | Floor | Location | Description | Access. | (A)<br>Product Type | (B)<br>Condition | (C)<br>Surface Treatment | (D)<br>Asbestos Type | Material Assessment Score (A + B + C + D) | Priority | Photo |
|---|---|---|---|---|---|---|---|---|---|---|---|---|
| 14 | B-50239/014 | Second Floor | 201 New lift Area – Wall Behind Plasterboard | Panels | Low | 2 | 0 | 1 | 1 | 4 | Low | |

| Ref | Sample No | Floor | Location | Description | Access. | (A)<br>Product Type | (B)<br>Condition | (C)<br>Surface Treatment | (D)<br>Asbestos Type | Material Assessment Score (A + B + C + D) | Priority | Photo |
|---|---|---|---|---|---|---|---|---|---|---|---|---|
| 10m² | | AD | Remove If Affected Bu Proposed Refurbishment Works | Work with this material to be carried out in accordance with The Control of Asbestos Regulations (2012.). All waste to be disposed of in accordance with the Hazardous Waste Regulations 2005. | | | | | | | | |

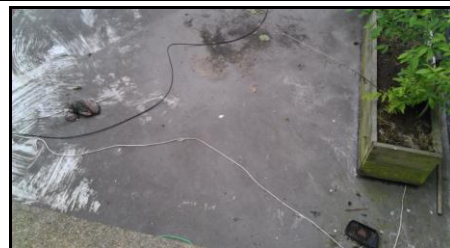
| Ref | Sample No | Floor | Location | Description | Access. | (A)<br>Product Type | (B)<br>Condition | (C)<br>Surface Treatment | (D)<br>Asbestos Type | Material Assessment Score (A + B + C + D) | Priority | Photo | |
|---|---|---|---|---|---|---|---|---|---|---|---|---|--|
| 17 | B-50239/017 | External | Front Entrance Roof | Roofing Felt | Low | 1 | 0 | 0 | 1 | 2 | Low | | |

| Ref | Sample No | Floor | Location | Description | Access. | (A)<br>Product Type | (B)<br>Condition | (C)<br>Surface Treatment | (D)<br>Asbestos Type | Material Assessment Score (A + B + C + D) | Priority | Photo | |
|---|---|---|---|---|---|---|---|---|---|---|---|---|--|
| 10m² | | AD | Remove If Affected Bu Proposed Refurbishment Works | Work with this material to be carried out in accordance with The Control of Asbestos Regulations (2012.). All waste to be disposed of in accordance with the Hazardous Waste Regulations 2005. | | | | | | | | | |

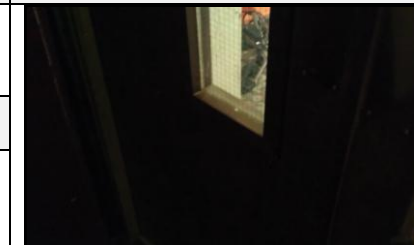
| Ref | Sample No | Floor | Location | Description | Photo |
|---|---|---|---|---|---|
| 3 | B-50239/003 | Second Floor | 201 New lift Area - Door | Putty To Door Window | |
| 2 lm | | NAD | | | |

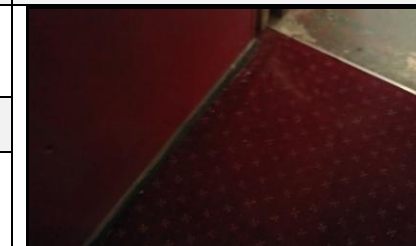
| Ref | Sample No | Floor | Location | Description | Photo |
|---|---|---|---|---|---|
| 4 | B-50239/004 | Second Floor | 201 New lift Area – Floor Void | Debris | |
| 5m² | | NAD | | | |

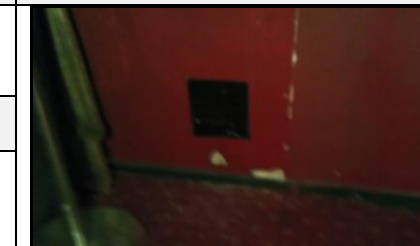
| Ref | Sample No | Floor | Location | Description | Photo |
|---|---|---|---|---|---|
| 7 | B-50239/007 | Second Floor | 201 New lift Area – Wall Cavity | Residue | |
| Throughout | | NAD | | | |

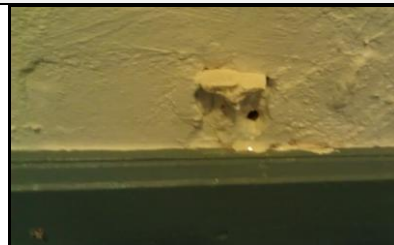
| Ref | Sample No | Floor | Location | Description | Photo |
|---|---|---|---|---|---|
| 10 | B-50239/010 | First Floor | 101 New lift Area – Wall Cavity | Residue | |
| Throughout | | NAD | | | |

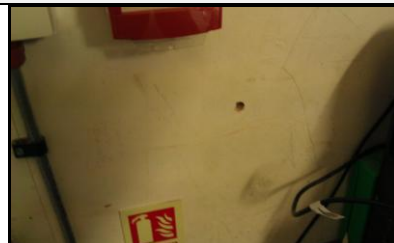
| Ref | Sample No | Floor | Location | Description | Photo |
|---|---|---|---|---|---|
| 13 | B-50239/013 | Ground Floor | 001 New lift Area – Wall Cavity | Residue | |
| Throughout | | NAD | | | |

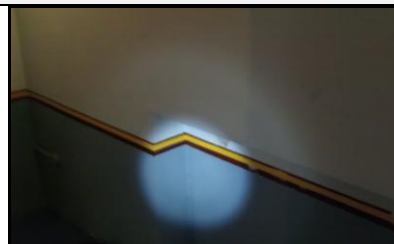
| Ref | Sample No | Floor | Location | Description | Photo |
|---|---|---|---|---|---|
| 15 | B-50239/015 | First Floor | 101 New lift Area – Wall Cavity | Residue | |
| Throughout | | NAD | | | |

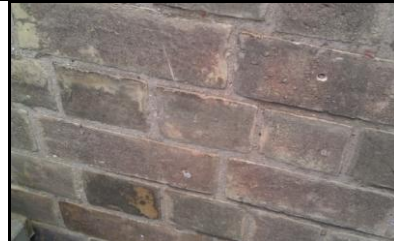
| Ref | Sample No | Floor | Location | Description | Photo |
|---|---|---|---|---|---|
| 16 | B-50239/016 | External | External – Wall Cavity | Residue | |
| Throughout | | NAD | | | |

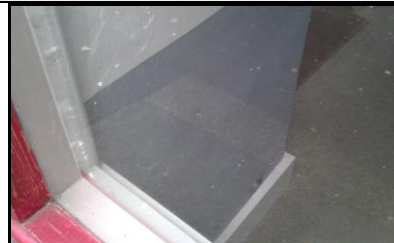
| Ref | Sample No | Floor | Location | Description | Photo |
|---|---|---|---|---|---|
| 18 | B-50239/018 | Ground Floor | 001 New lift Area – Wall Cavity | Residue | |
| Throughout | | NAD | | | |
